Colluvial Deposits and Associated Landslides in the Northern San Francisco Bay Area, California, U.S.A.

S.L. Reneau, W.E. Dietrich, C.J. Wilson

SYNOPSIS

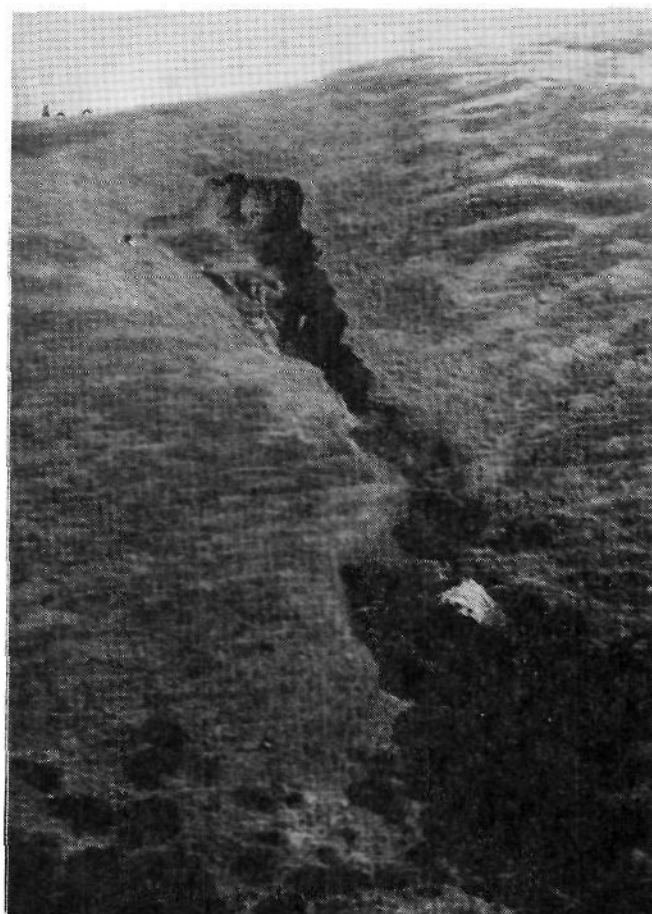
Fig. 1. Landslide scar in Lone Tree Creek basin, Mount Tamalpais, Marin County. Landslide occurred in 1974 (Lehre, 1982), centered along the axis of a colluvial deposit that had a maximum thickness of 4.5 m. The eroded failure plane is visible as a bench within the scar, 2 m deep. The boundary of the deposit is recognized by tonal changes in the grass. Photo taken in 1983 (M. Sloan).

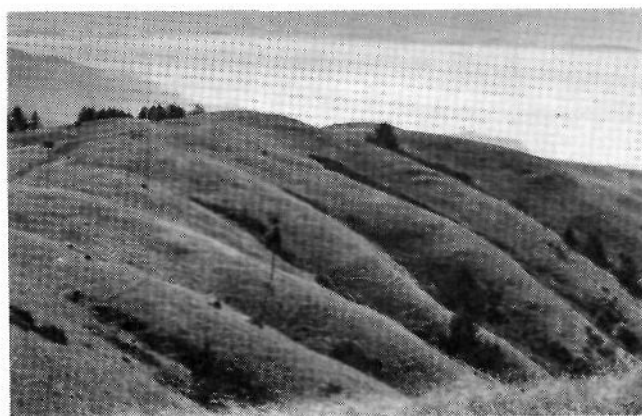
Fig. 3. Ridgecrest at head of Lone Tree Creek showing a series of swales separated by low divides. Each swale is underlain by a thick colluvial deposit and landslide scars are visible in several of them. Lehre (1982) found that the colluvial deposits are the primary source of debris flows in this drainage basin. View south, with entrance to San Francisco Bay in upper left (M. Sloan).

In the San Francisco Bay area the colluvial deposits are typically 2–4 m thick, some reaching 10 m or more in thickness. They are usually located in subtle swales near ridgecrests, as in Fig. 3 and Fig. 4. The deposits are common on hillslopes underlain by bedrock that yields coarse-textured soils. Such bedrock includes sandstone, granite, chert, and greenstone, and the soils are typically SM, GM, or ML in the Unified Soil Classification System. The colluvial origin of the hillslope soils in this region is conceptually

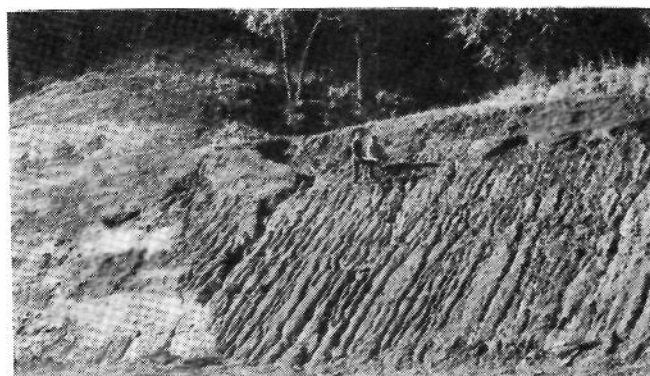
Fig. 5. Colluvium exposed in road cut near Point San Quentin, Marin County. The two people are located at the transition between densely rilled lower colluvium and darker, root-permeated upper colluvium. At the time of the photograph a perched water table had developed above this transition. Bedrock exposed to left along a steep contact with the colluvium is graywacke sandstone of the Franciscan assemblage.

The colluvial deposits are most easily observed in roadcut exposures where they are found to mantle U- or V-shaped bedrock hollows (see Fig. 5). In the northern San Francisco Bay area these deposits usually do not completely obscure the bedrock topography and a good first approximation of their location can be made by mapping the subtle topographic lows on the hillslopes. At some sites vegetation contrasts in combination with subtle slope changes can be used to delineate the boundaries of a deposit (see Fig. 1, Fig. 2, and Fig. 4). A crude correlation exists between certain vegetation and thick colluvial deposits, probably reflecting a change in moisture availability. There is frequently little or no topographic expression and in this case recognition is difficult without subsurface data, such as from road cuts, drilling, or seismic refraction profiles. Historically, when colluvial deposits were encountered in the field by geotechnical engineers they were not generally identified as potentially unstable or as sources of debris flows. The following is a case in point.

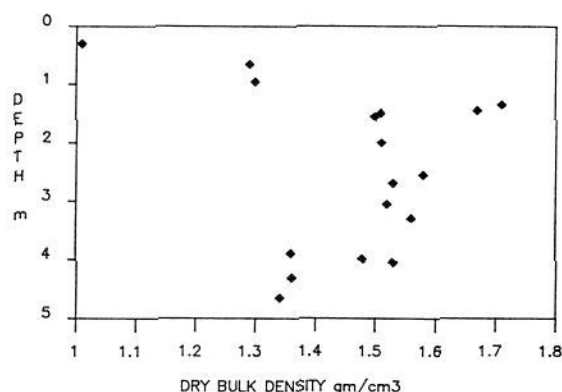
Fig. 11. Bulk density profile through a colluvial deposit near San Rafael, Marin County, sampled in eroded landslide scar. Thin horizon of relatively high density occurs at 1.25 m depth and is associated with a zone of pedogenic clay accumulation; the main failure plane occurred immediately above this. The low density lower horizon is composed of loose, openwork, angular gravel. Bedrock is graywacke sandstone of the Franciscan assemblage.
